Chase Field Repairs

BY DENNIS WIPF

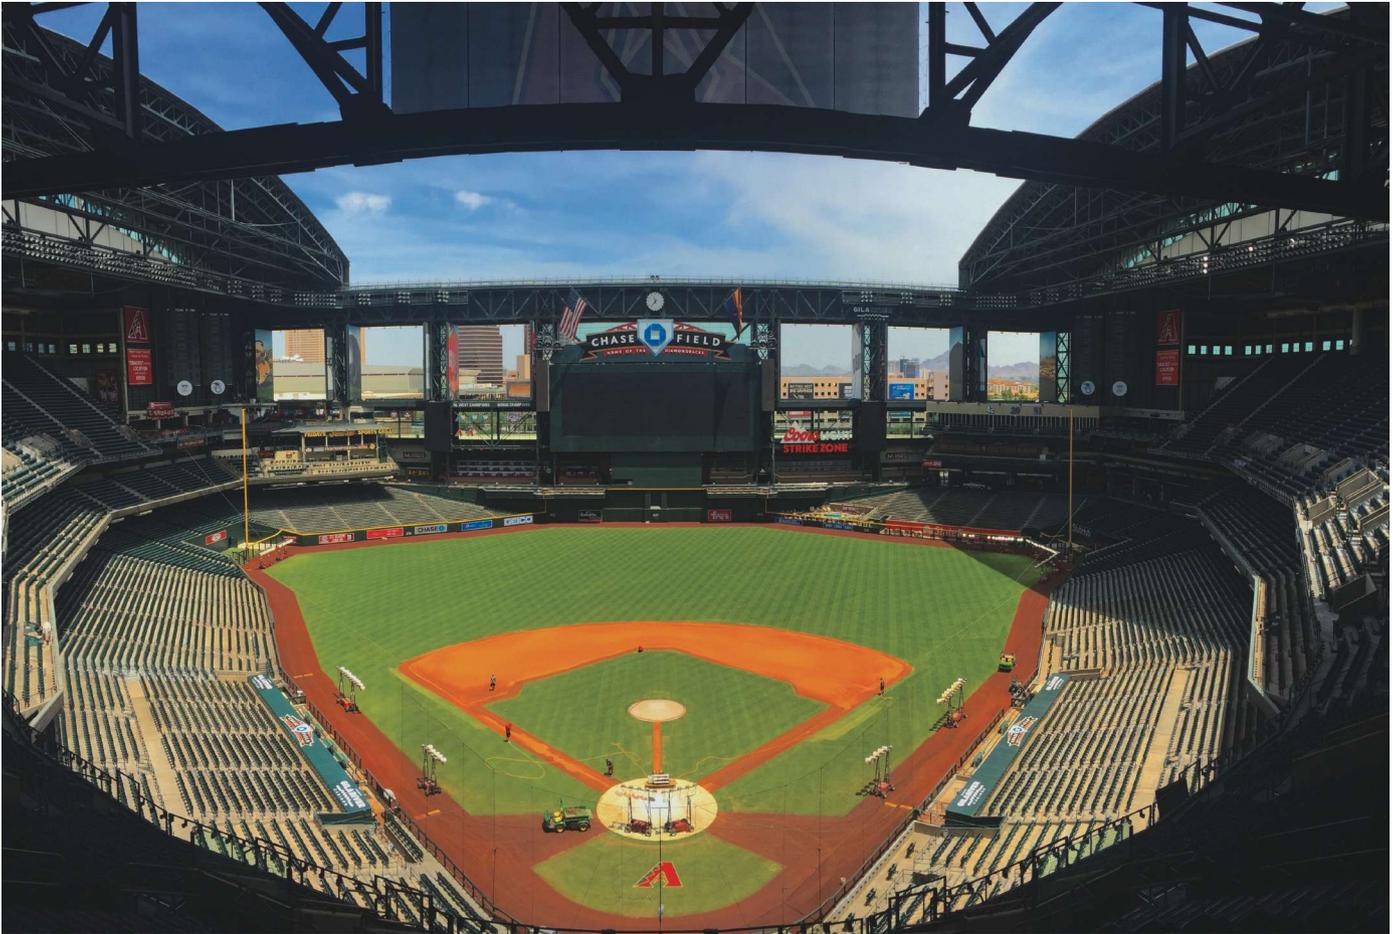
Fig. 1: Interior view of Chase Field

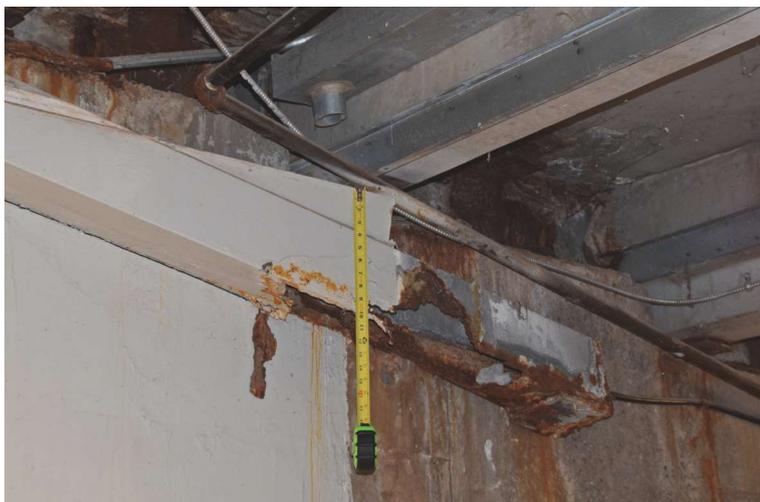
- Although the original design did not include waterproofing, it did include an extensive gutter system beneath the precast joints to collect water if joints leaked, diverting the water to uninhabited spaces (Fig. 2). As a result, corrosion damage occurred to the structure as water leaked through the joints, traveling across structural members before entering the gutters.

Fig. 2: Bottom side of seating riser at support—seating riser bearings and seismic restraint plates are visible on the bottom side. Moisture penetration through building expansion joint into mineral wool (each side of L-shaped plate) resulted in severe corrosion. Rain gutter system completely corroded through as it enters uninhabited space.

Each precast seating riser is supported at its ends by steel raker trusses or concrete raker beams/walls. Water leaking through these deteriorated joints corroded precast connections and the supporting structure. Threaded rebar anchors are directly below these joints, and gutters are located on each side of the concrete raker beams/walls. However, water drips down from the joint, onto the top of the beam/wall, into the precast bearing area, and down the face of the beam/wall, before being collected into the gutter (Fig. 2). Therefore, supporting member damage has occurred.

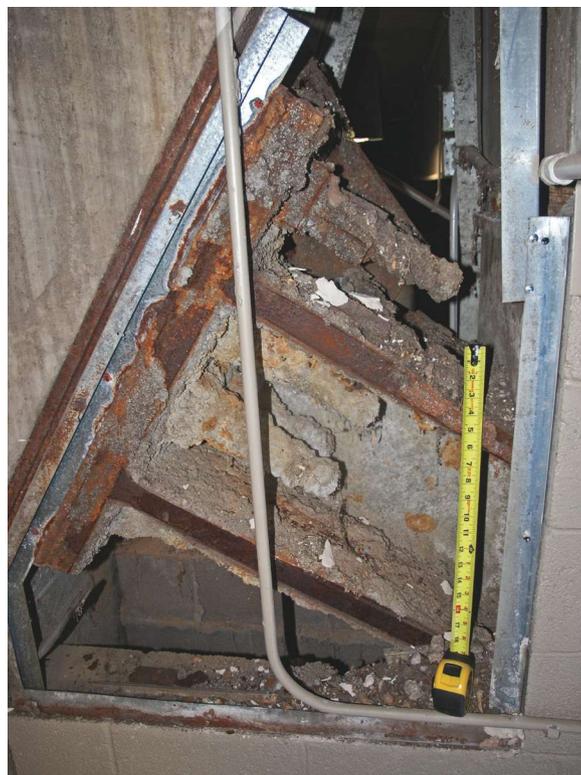
Fig. 3: Raker truss tieback anchor—connection between steel raker truss and concrete frame with sixteen 1-3/8" (35mm) diameter high strength threaded rebar anchor rods. Connection is completely hidden between two masonry walls in a dead space with leaking precast joint directly above. Spray-applied fireproofing absorbs water and never dries out.

Large cantilevered steel raker trusses support the first 11 rows of seating at the Upper Concourse and are connected to concrete columns with high-strength threaded rebar. Sixteen 1 $\frac{3}{8}$ in (35 mm) diameter threaded anchor rods are embedded into concrete columns and raker beams to transfer the 200,000 pound (90,720 kg) tension force from the steel raker truss to the concrete. This very critical structural connection is concealed between two masonry walls in a small inaccessible “dead space,” with leaking precast caulk/building-expansion joints directly above. The spray-applied fireproofing absorbed moisture, never drying out, promoting corrosion. This connection and associated damage was not readily visible without removing a sheetrock cover, but infiltration was evident in the form of efflorescent stains on the column and raker beam (Fig. 3 through 5).

- Removing all fireproofing;
- Sandblasting all steel to a white metal finish;
- Unscrewing the threaded rebar nuts, one at a time;
- Inspecting for damage and replacing nuts as needed;
- Sandblasting the rods and nuts;
- Coating all elements with epoxy before assembly;
- Re-torqueing nuts;
- Repeating this process 15 more times for other anchors;
- Chipping out original grout across top, exposing four top anchors;
- Applying migrating corrosion inhibitor;
- Replacing grout with epoxy grout;
- Injecting epoxy between concrete column and steel embed plate;
- Coating raker truss and threaded rebar anchors with intumescent epoxy; and
- Installing waterproof flashing to prevent moisture from leaking directly onto the anchor assembly.

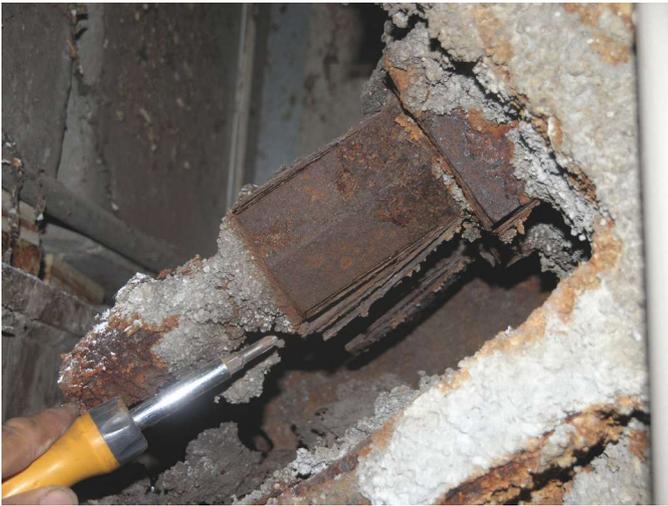
Fig. 4: Threaded rebar anchor nut—Severe deterioration of the nut. Corrosion of the threaded anchor rod is not visible due to fireproofing and debris.

Thirty-two raker truss connections occur at the upper seating level. They were investigated, prioritized for severity, and 19 locations repaired. If the rods were severely corroded, repairing them to replace lost cross-sectional area would have been extremely difficult. Fortunately, even though standing water was found in the grout pocket directly above the threaded rebar, none of the anchor rods had experienced enough corrosion that repairs were required to restore the rod’s tensile strength. Many nuts were severely corroded and required replacement.

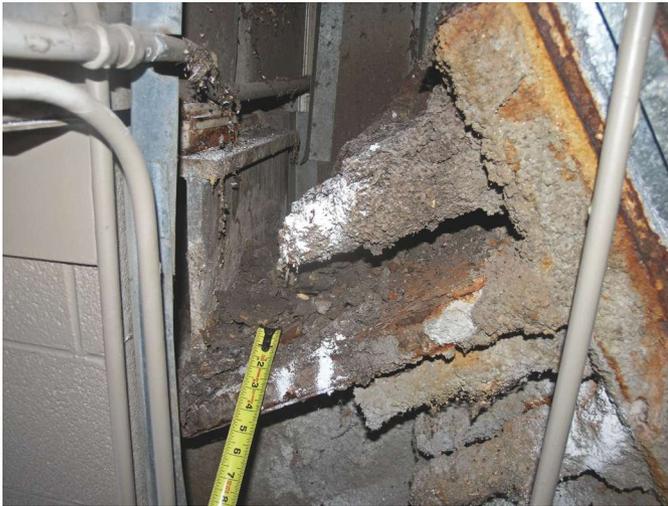
Fig. 5: Threaded rebar anchor—large mound at end of tape measure is peanut shells and debris washed through failed joint above.

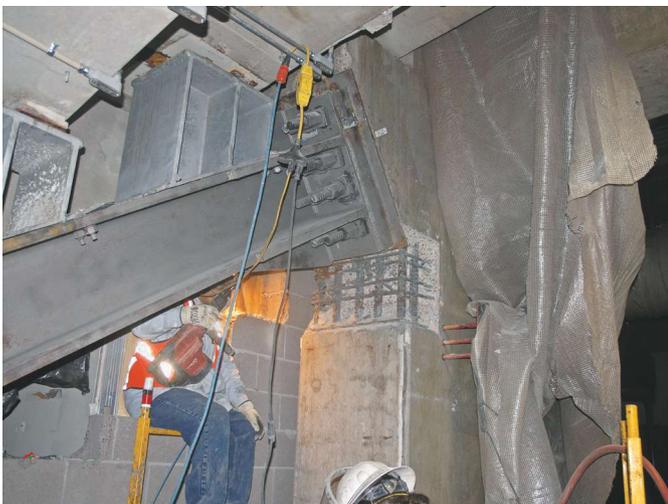
Fig. 6: Raker truss tieback anchor connection—overall view of the threaded rebar anchor assembly after initial sandblasting.

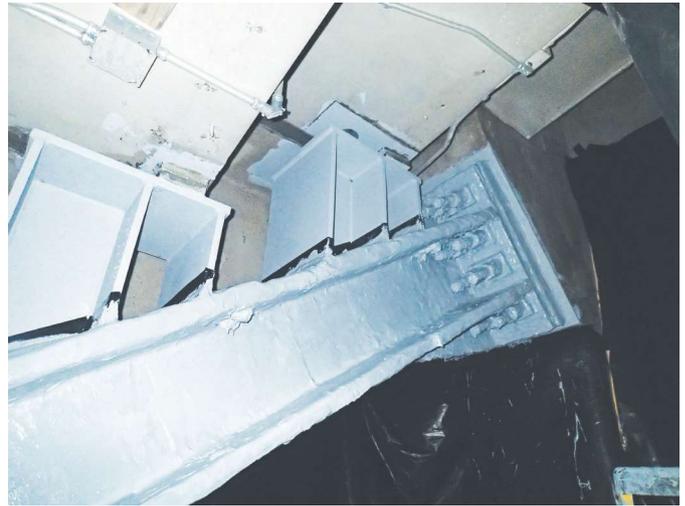
Fig. 7: Raker truss tieback anchor connection—completed repair with epoxy intumescent fireproofing to achieve 3 hour fire rating and provide corrosion protection to the beam and threaded rebar anchors.

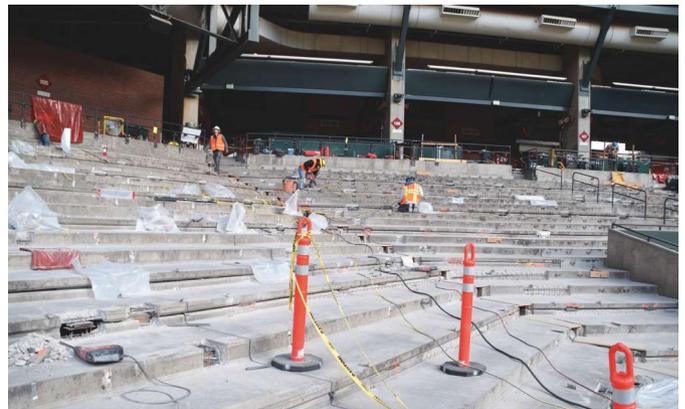
Much of the work has involved the precast seating risers (Fig. 8), and the structures below them due to leaking joints between the precast sections. Precast seating risers have numerous joints, between ends where they butt together (transverse), and longitudinally between sections. Most of these joints are caulked; however, seven are building-expansion joints. All joints were not maintained on a consistent basis. Damage from frequent power washing, traffic and the ex-

Fig. 8: Repairs to precast seating risers

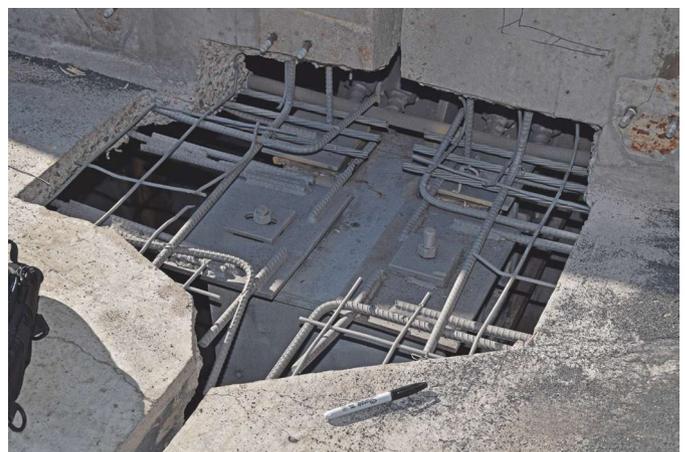
Precast members are supported by typical embedded plates at bearings. Bearing plates embedded in precast members, steel shims, and bearing plates in supporting members all experienced various levels of corrosion. Building-expansion joints incorporating sliding bearing assemblies suffered even more deterioration. Repairs varied from simply sandblasting exposed surfaces of the bearings and epoxy coating, to full depth concrete removals in both precast and supporting members to replace bearing plates/pads, sandblast and epoxy coat exposed steel surfaces, and re-cast the section (Fig. 9 and 10).

To restrain seismic loading, a large steel embed plate was cast into the seating riser's horizontal portion directly adjacent to the transverse joints. These seismic connections experienced deterioration in many cases. Often, repairs encompassed both bearing and seismic areas on each row of seating (Fig. 9, 11 and 12).

Fig. 9: Typical precast joint repairs—seismic restraint plate (embed with bolt) and precast bearing seat assembly (below prestressing strands) after existing plates replaced, rebar welded back, and sandblasted prior to epoxy coating and pour back.

To protect the repairs against future corrosion, all exposed steel embeds and rebar were epoxy coated, with the second coat also used as a bonding agent. Building expansion joints utilized pre-compressed, silicone-impregnated foam expansion material to provide a long-lasting waterproof joint, with walking surfaces suitable for high-heeled shoes without the need for metal cover plates.

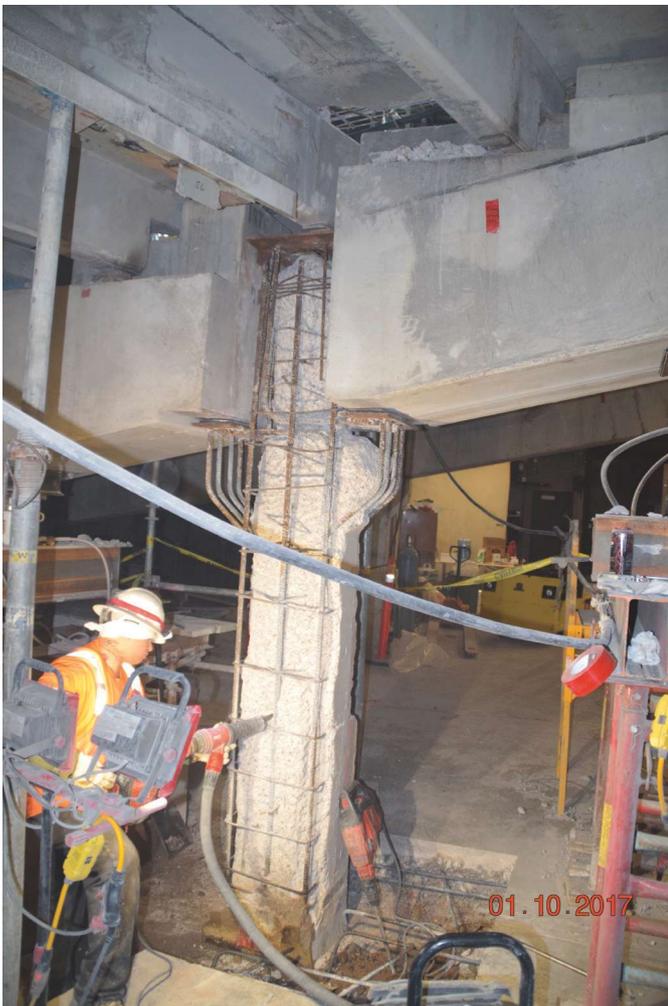
Fig. 10: Concrete column repairs—due to placement logistics, the contractor elected to repair this column rather than replace it.

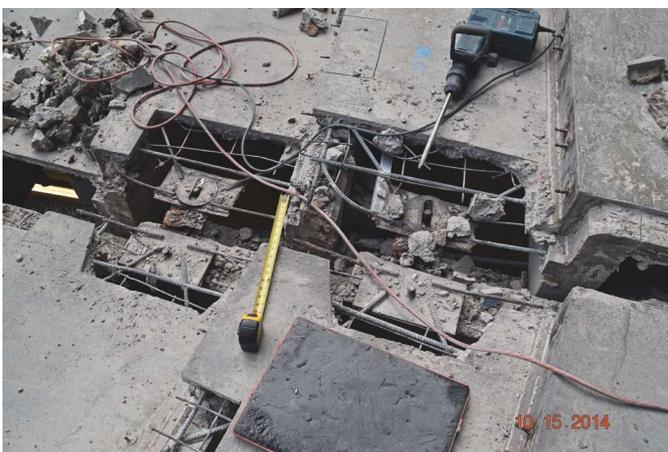
Fig. 11: Typical Precast Joint Repairs - Water leaking through building expansion joint between precast seating sections was absorbed by mineral wool fireproofing in the joint, resulting in severe deterioration. Large steel plates are seismic restraints.

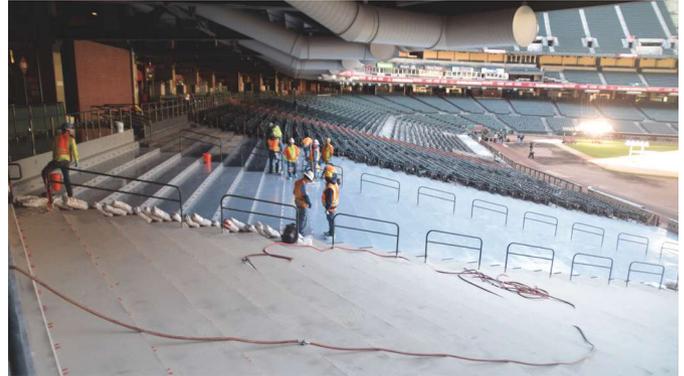
Fig. 13: Deck coating application at precast seating risers.

To protect the concrete against moisture infiltration, a urethane deck coating was applied (Fig. 13). The deck coating primer was a super-low-viscosity healer-sealer epoxy, applied by flood coat with sand.

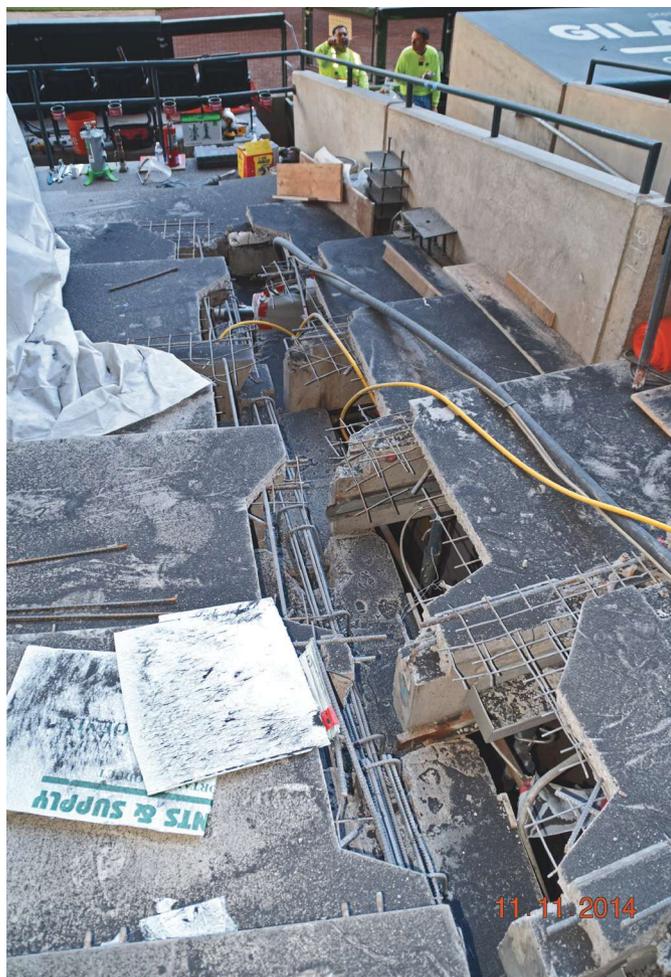
Fig. 12: Precast joint repairs—typical example of demolition required to repair the joints between the precast seating sections. Seismic restraint plates have been completely removed for replacement. Bearing repairs for stems have not started. Virtually every row was affected.
